U.S. DEPARTMENT OF AGRICULTURE  
FOREST SERVICE

Slope Stability Hazard Assessment  
of  
Hatchery Fire Complex  
Wenatchee National Forest

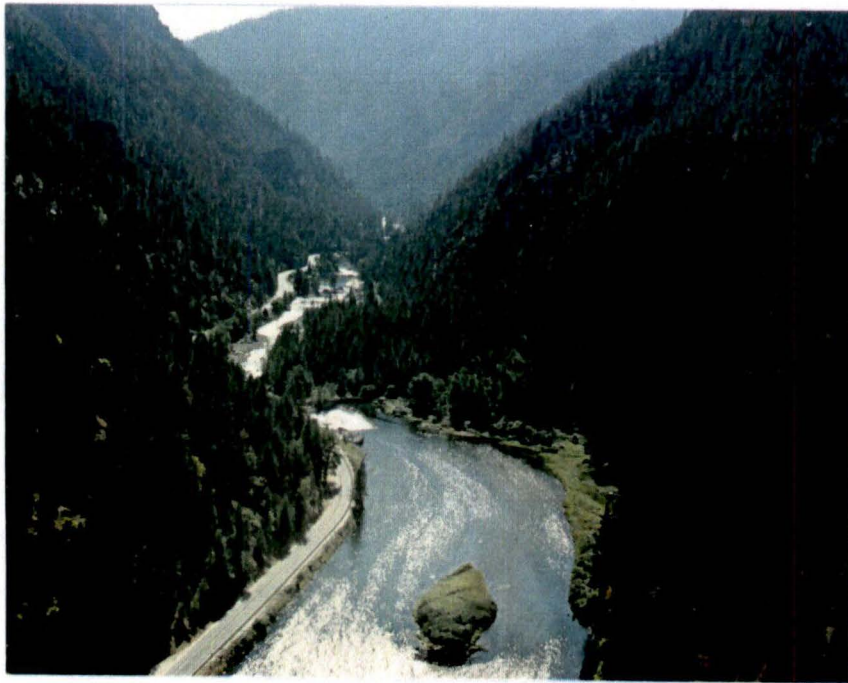
Figure 3. Tumwater Canyon looking south (downstream) with small concrete dam in center of photograph.

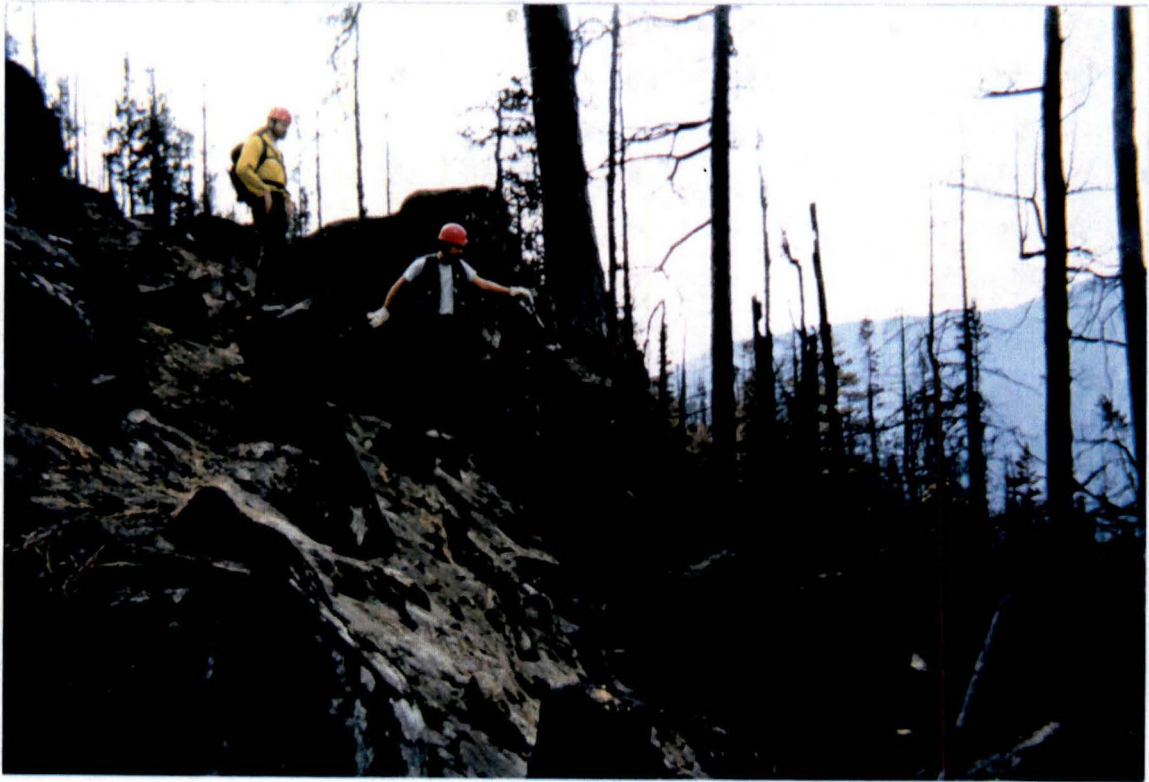
Figure 4. Potential 4 foot diameter rockfall supported by a tree near the ridge top in area T-3.

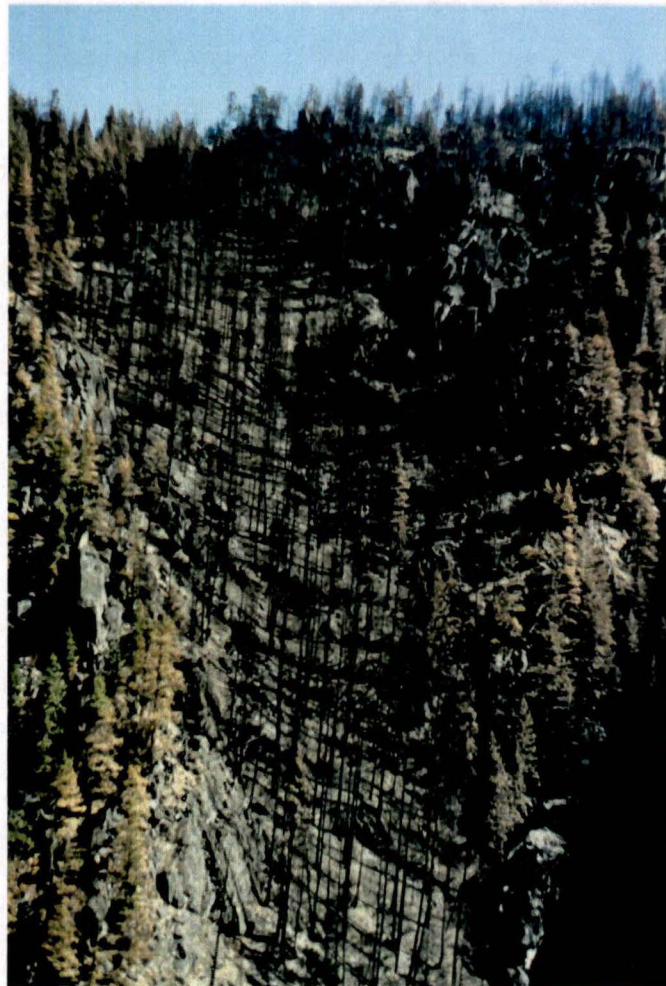
Figure 5 shows a potential rockfall-debris flow-snow avalanche area. In many of the areas studied there is a combination of rockfall-debris flow movement hazard potential.

Snow avalanches may occur in areas similar to those shown in Figure 5. Middle and upper slopes average 33 ° and the trees are probably dead from intense wildfire. If the stand of trees is removed and no replanting occurs, then an area such as this falls into Selby’s “optimum conditions” category.

Figure 5. Potential rockfall-debris flow-snow avalanche area within T-1.

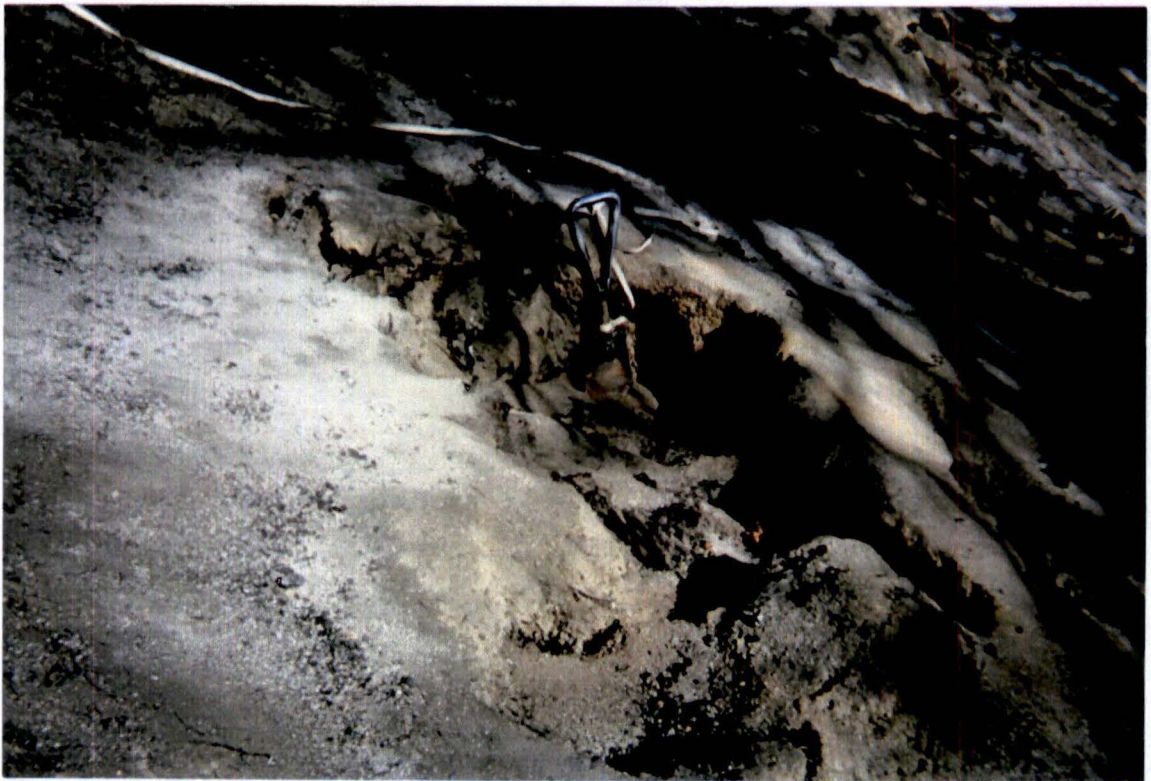
Figure 7. Complete tree root loss and macropore development from wildfire.

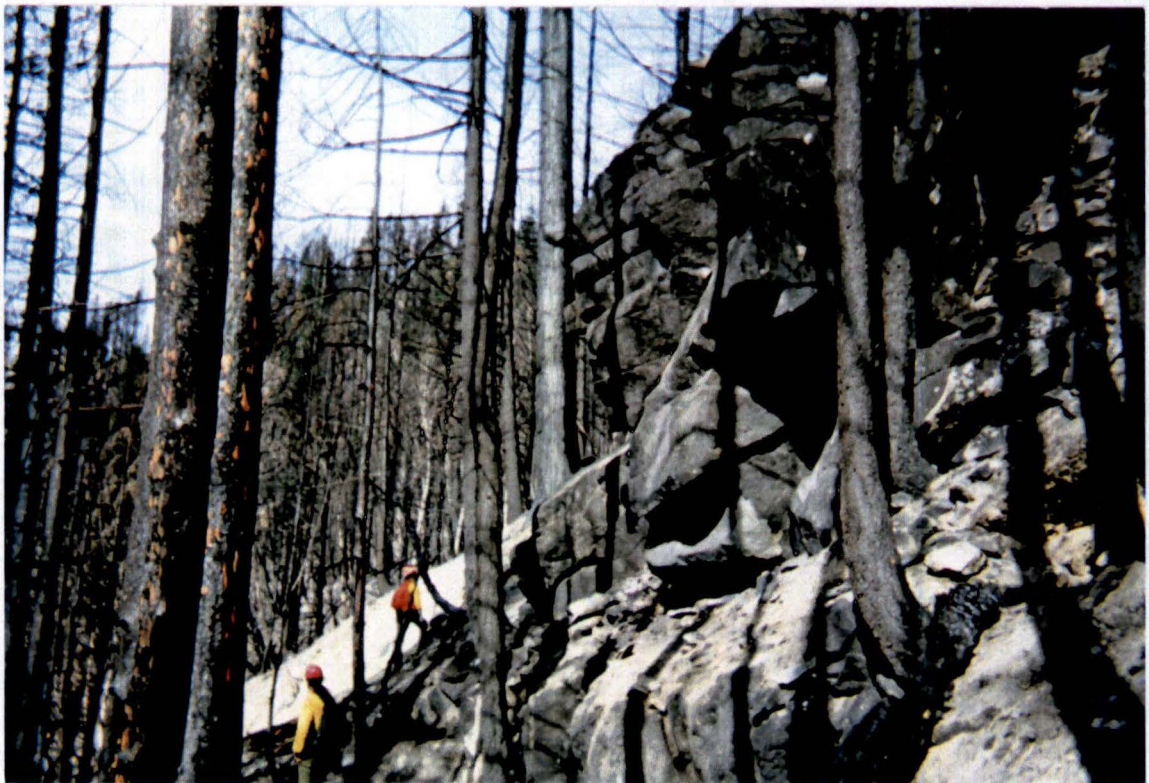
Figure 8. Rock outcrops with dip-slope discontinuities that were evaluated for stability using ROCKPACK (Watts and Associates, 1986).

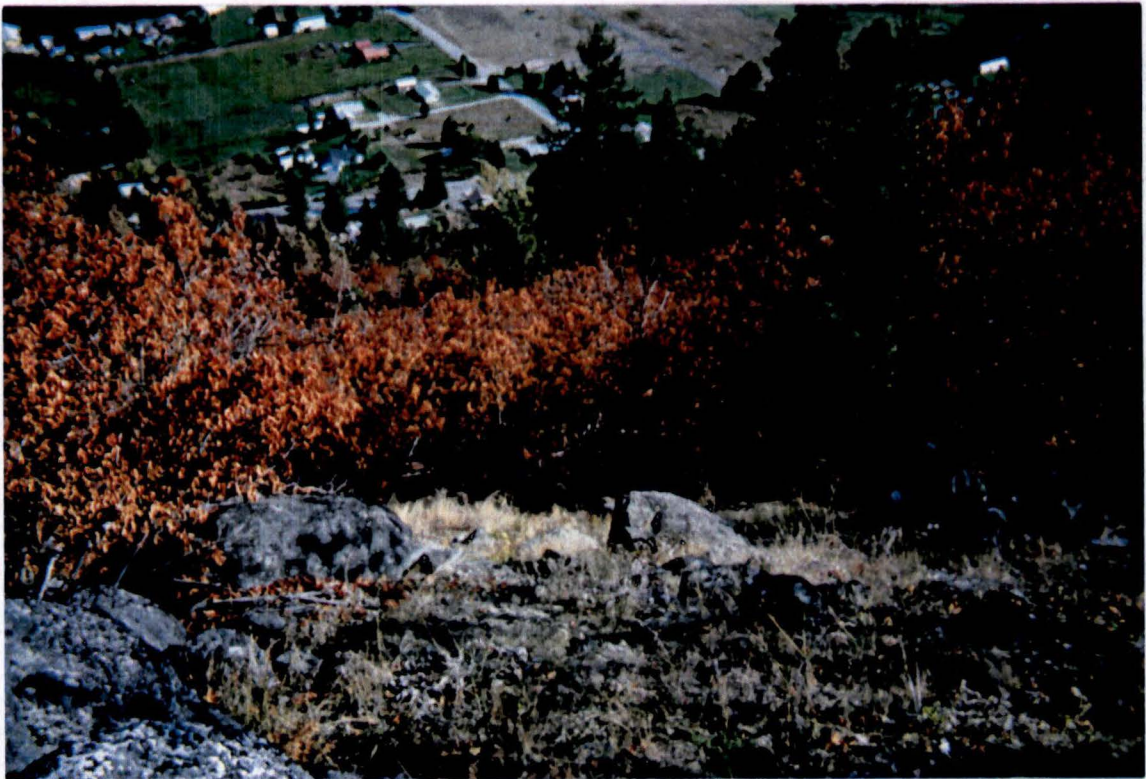
The fan below T-13 on the southern end of Tumwater Mountain has also been assigned a high hazard due to homes at risk (Figure 9). Debris flow deposits found in the channel above the fan and a debris slide appearing in the 1975 aerial photographs provide evidence of active slope movement. Also of concern at this location is the potential for additional unmitigated development on the fan. Clearing in a middle portion of the fan was in progress at the time of the field surveys.

Figure 9. *View of houses downslope from T-13. These houses are located on a previous debris flow runout deposit.*

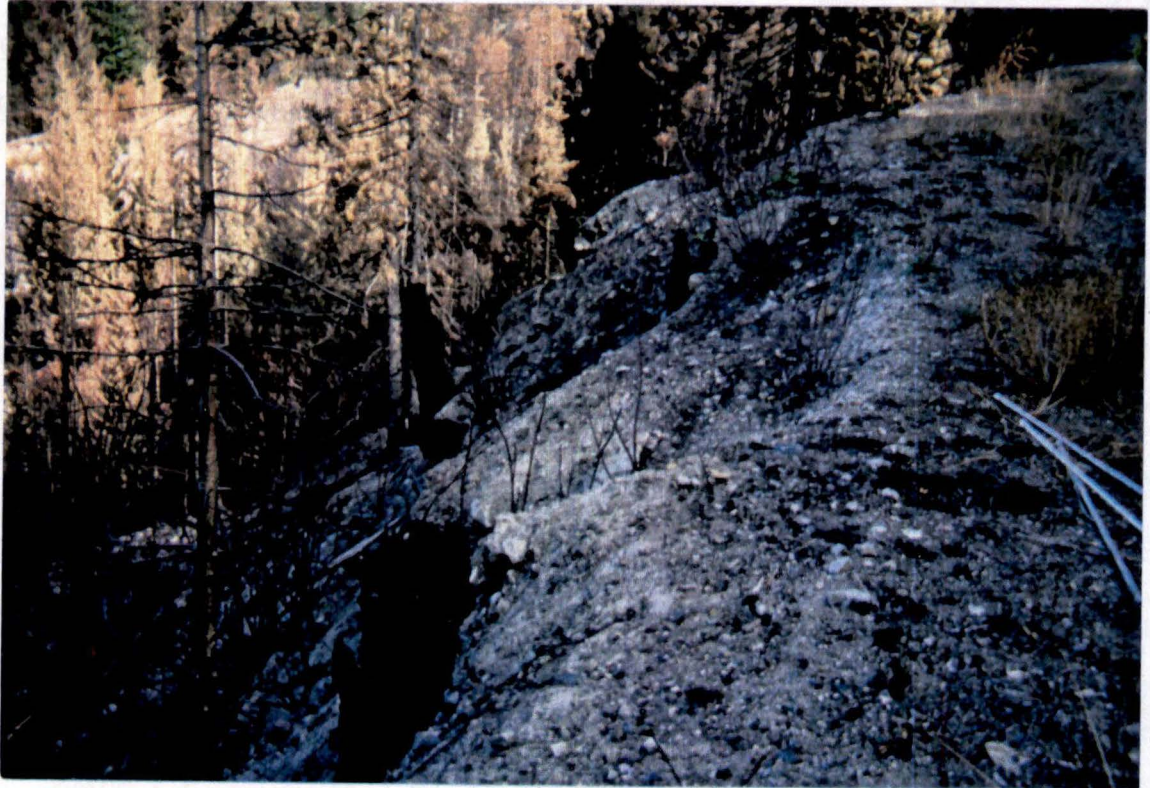
Within the managed areas, additional run-off and erosion with subsequent drainage problems associated with roads are the main post-fire impacts of concern (Figure 11).

Figure 11. *Run-off and erosion with subsequent drainage problems associated with roads are the main cumulative effects for post-fire impacts at the road shown here (in T-8).*

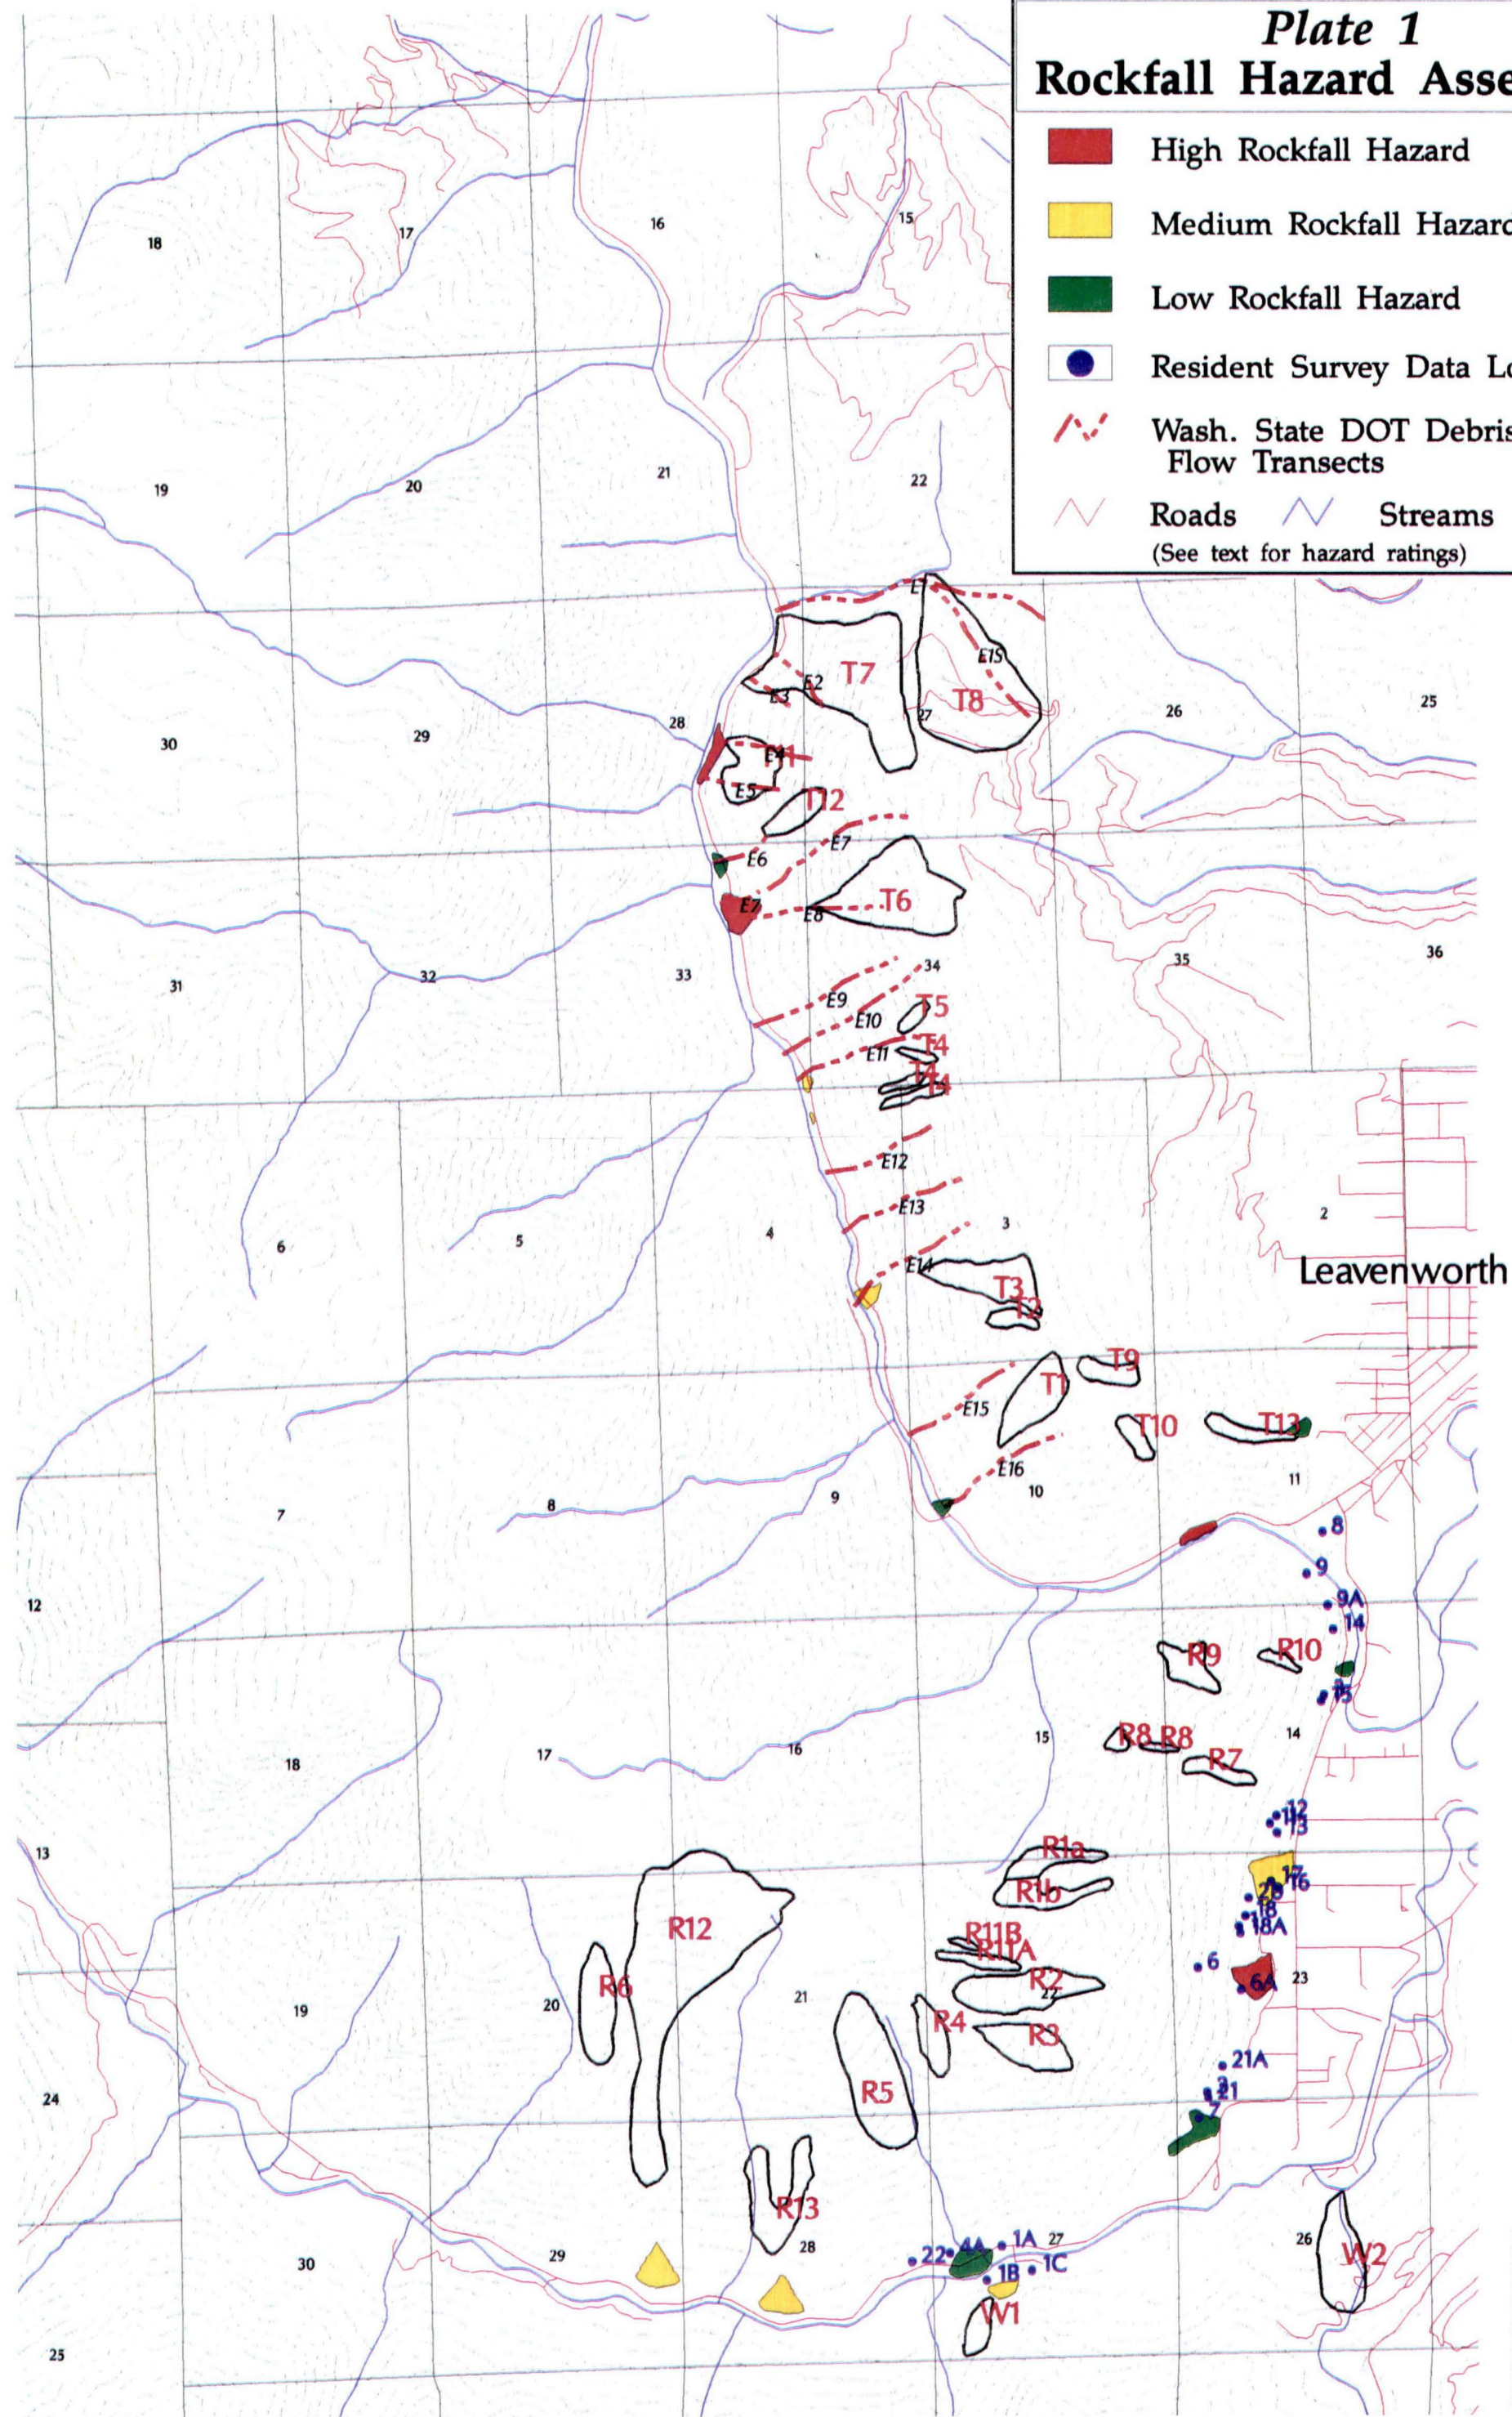
## Plate 1 Rockfall Hazard Assessment

Hazard ratings were assigned by 3 factors: 1) large rock source volume for rockfall failure; 2) kinetic energy > 50,000 ft-lbs (rockfall boulder energy); and 3) rockfall having a probability greater than 4% reaching S.R. 2 or structures. High ratings had 3, medium ratings had 2, and low ratings had < 2 factors. One area, T-6, had a hazard rating adjusted up from medium to high because it has a relatively larger maximum boulder size (4 ft ) compared to most other areas, and there are several structures that some large boulders may reach (5.6% probability). Hazard ratings displayed in Plate 1 are only for maximum-size boulders because no average-size boulders, except for area T-4, reached areas of concern. High hazard ratings were assigned to areas T-6, T-10, and T-11. Medium hazard ratings were assigned to areas T-3 and T-4. Low hazard ratings were assigned to T-1, T-12, and T-13. For a complete listing of hazard ratings for both average and maximum-size boulders, see Table 8 on page 29 in Part 2.

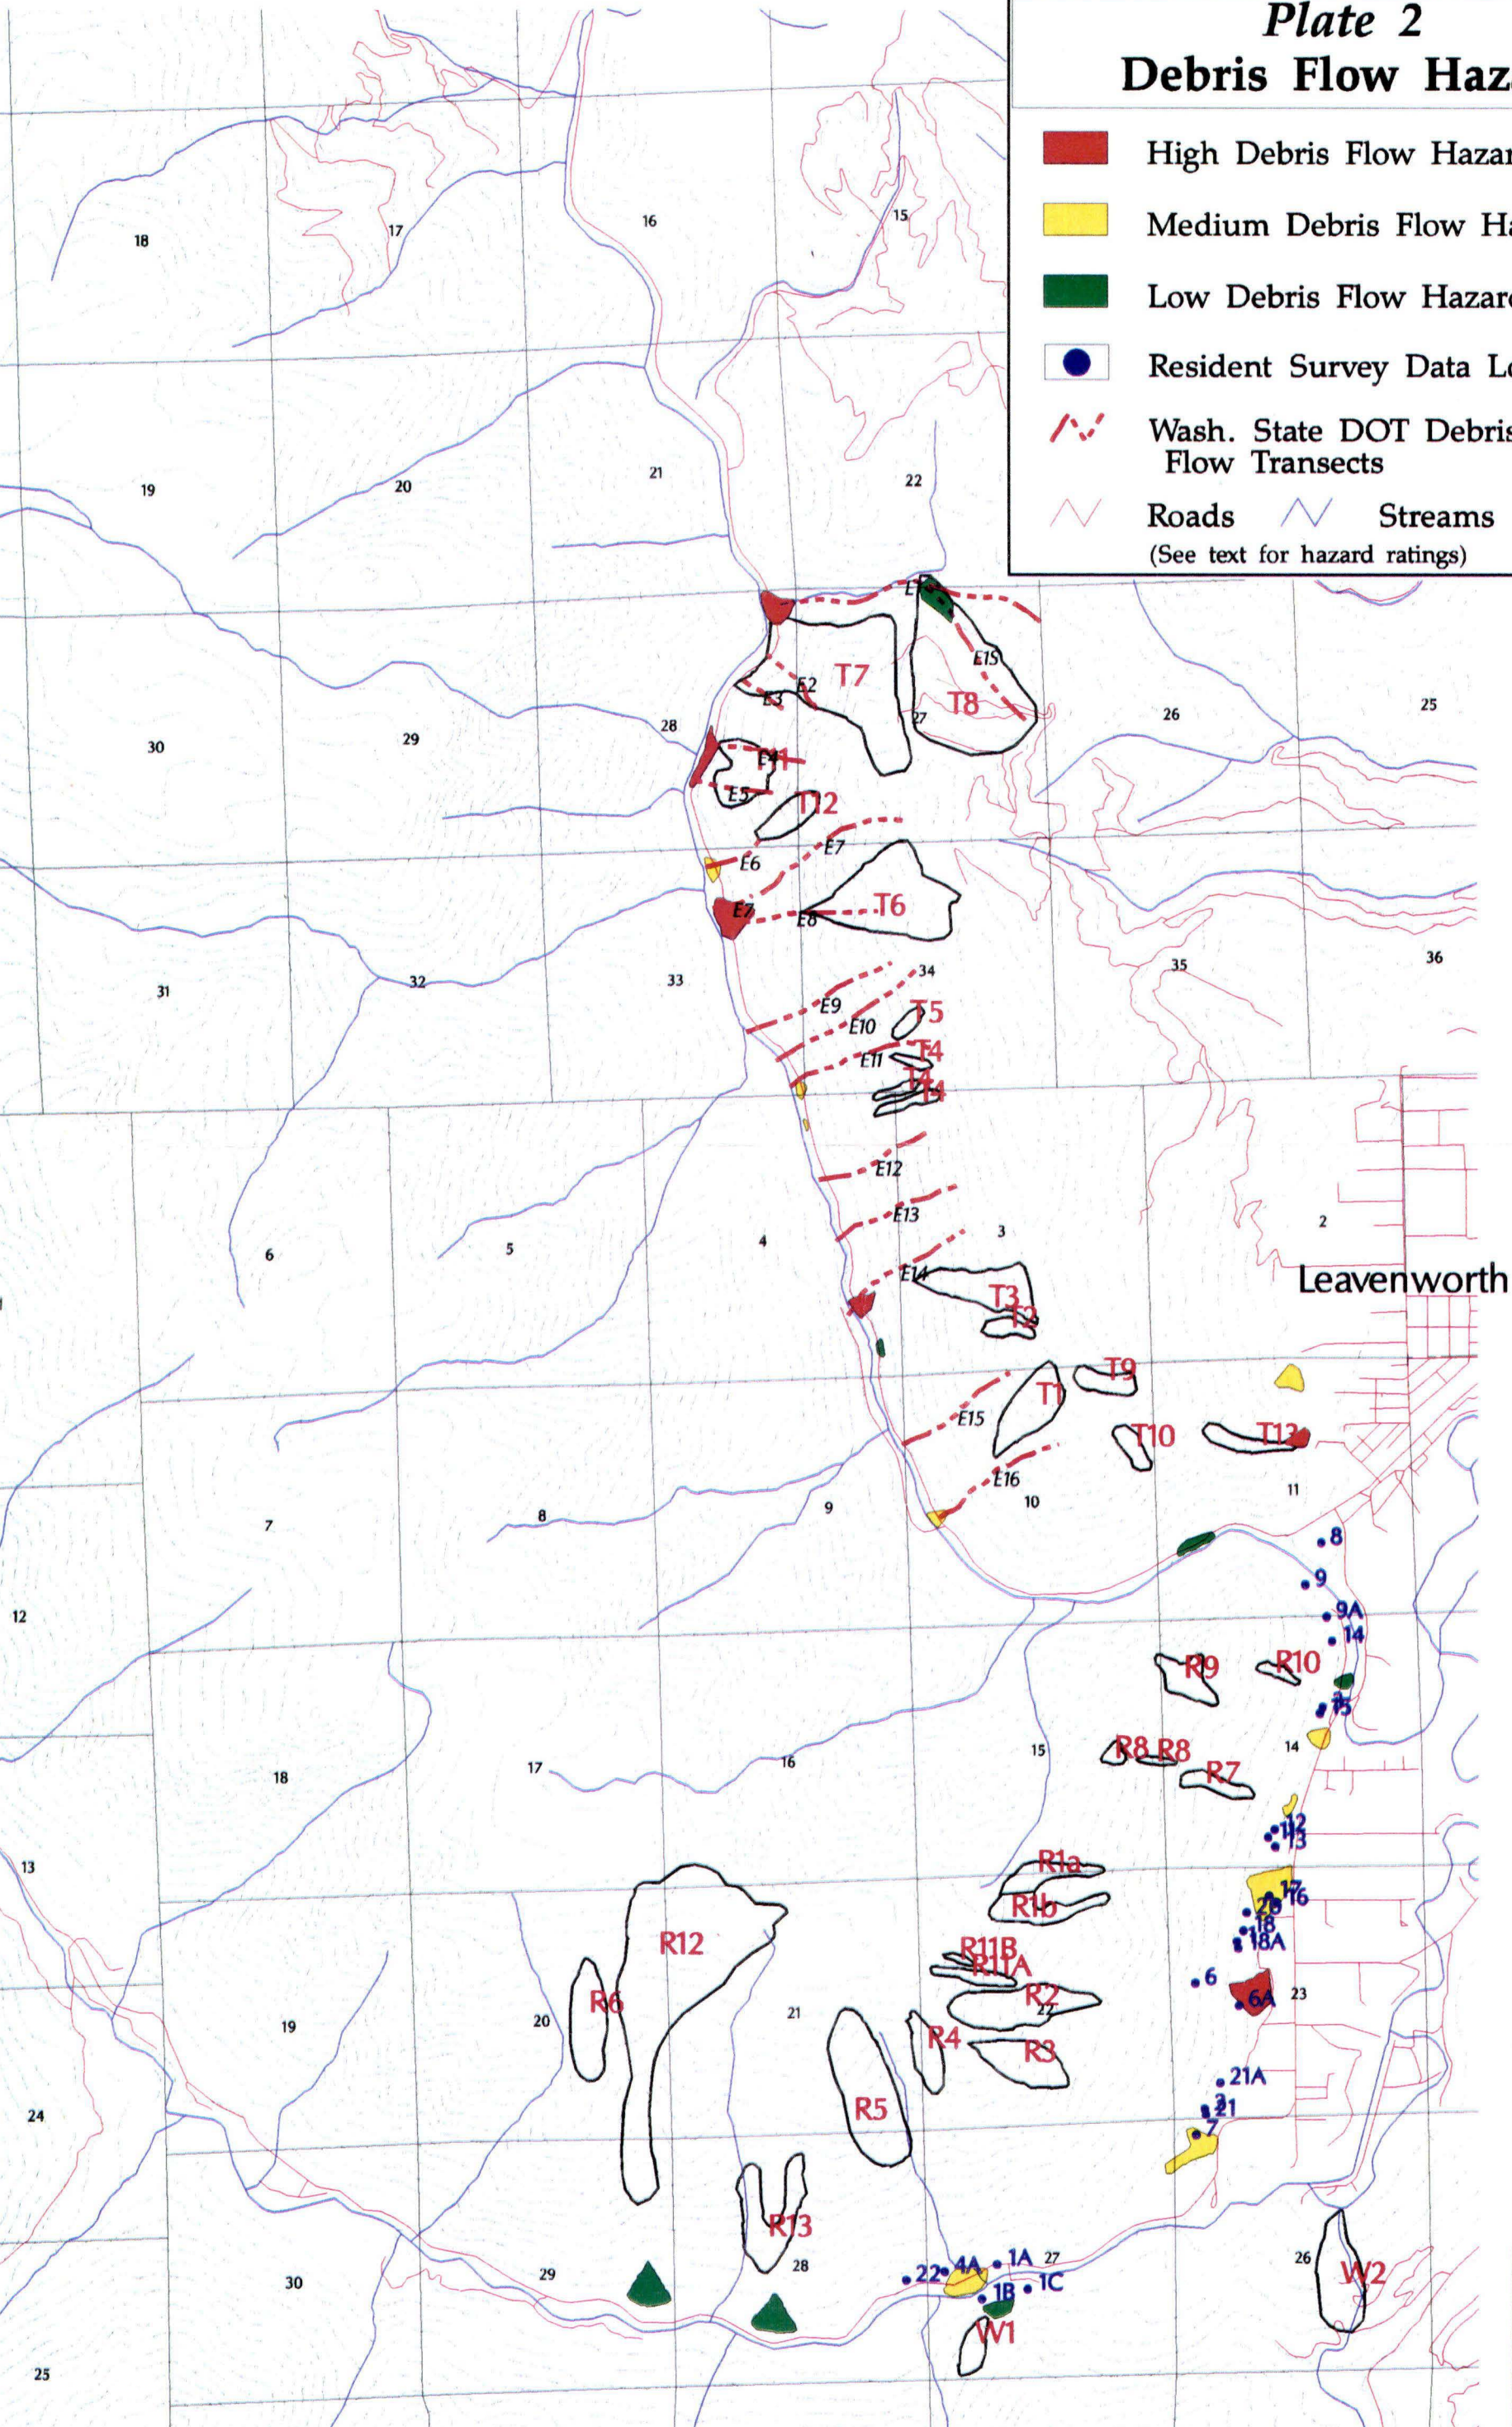
Plate 2  
Debris Flow Hazard

Factors used to assigned hazard ratings were the same used in evaluating debris flow activity in Tumwater Canyon. Two areas (R-2 and R-11a) were assigned high hazard ratings. Five areas (R-1a, R-1b, R-5, R-7, and R-9) were assigned medium ratings. One area (R-3) was assigned a low to medium rating. The rest of the areas were assigned low ratings (see Plate 2).

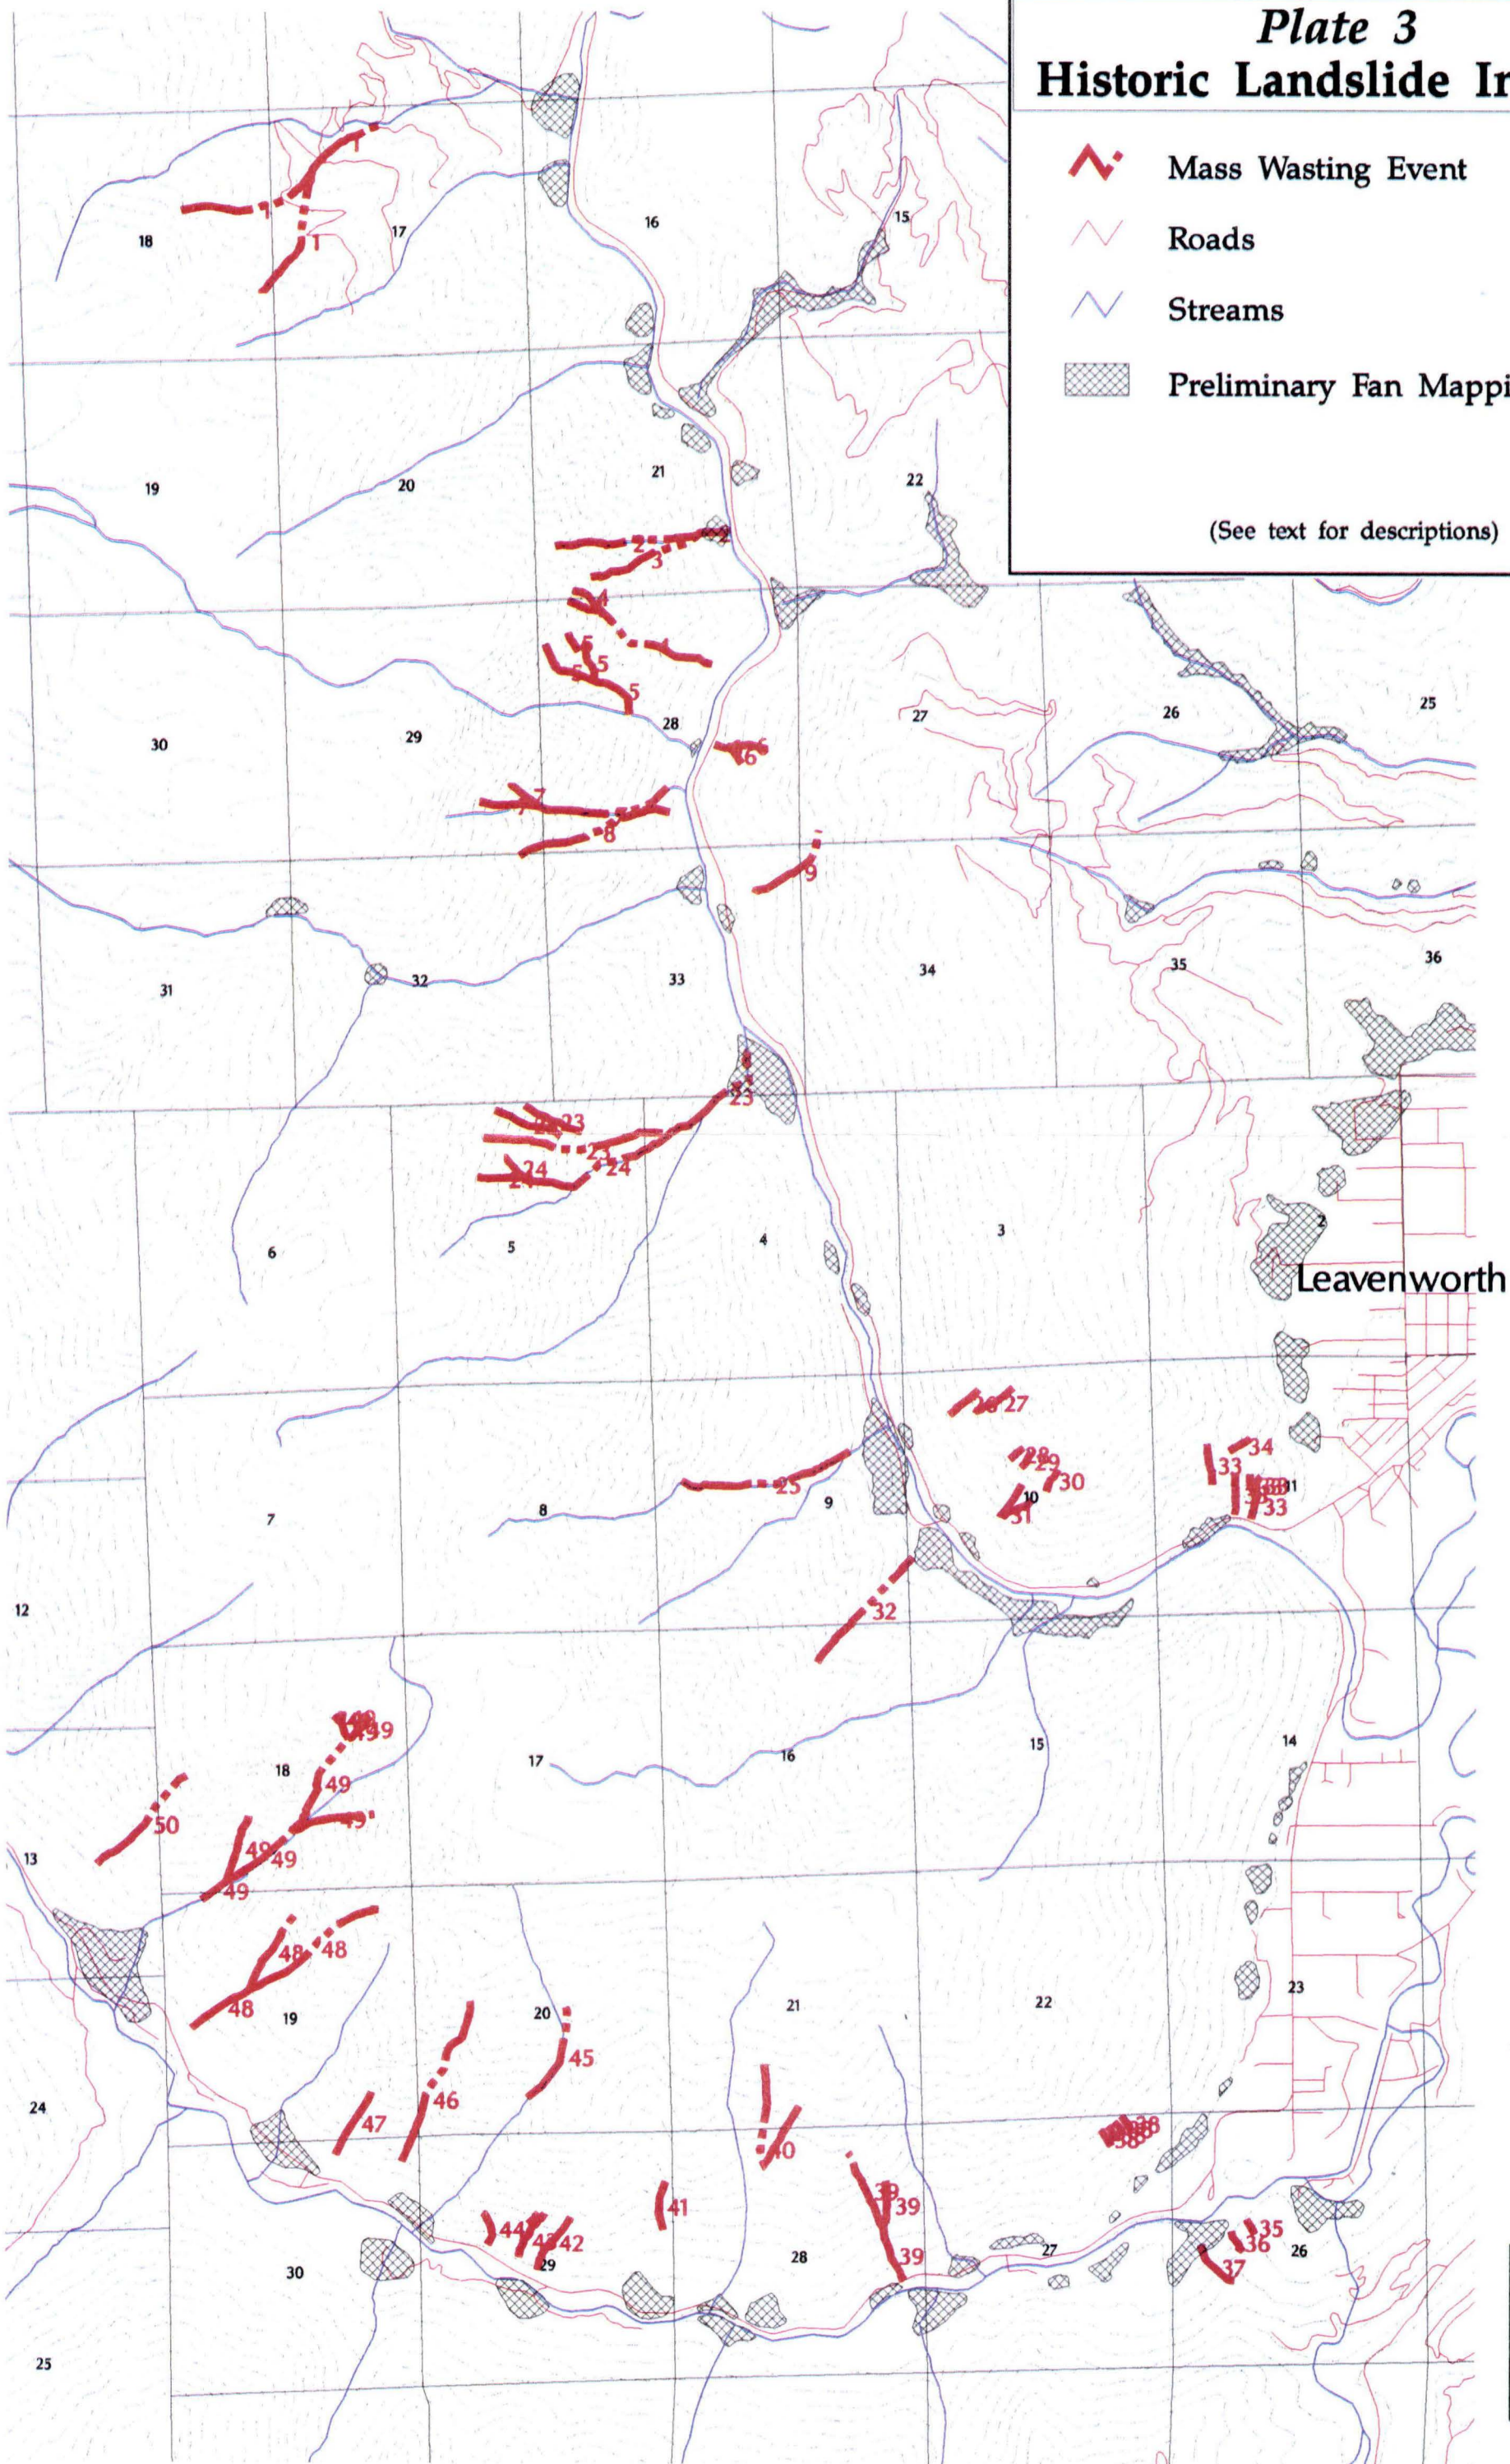
## Plate 3 Historic Landslide Inventory

Ten of the nineteen debris flow events, located in the aerial photography work, are on the west-facing slopes (see Plate 3). Debris flows on the east-facing slopes, unlike those on the west-facing slopes, have long runouts. The cause of this difference is probably that the east-facing slopes are higher, and longer than the west-facing slopes.
